Fire Risk Assessment of Low Cost High Rise Residential Buildings in Kuala Lumpur: A Case Study

Farid Wajdi Akashah*, Timothy Kurannen Baaki, and Shing Peng Lee

Centre for Building, Construction and Tropical Architecture (BuCTA), Faculty of Built Environment, University of Malaya (UM), 50603 Kuala Lumpur, Malaysia.

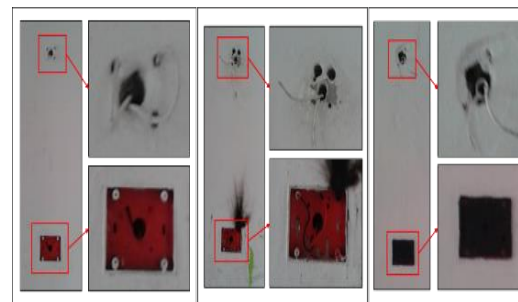
A smoke detector is provided only in the centre lift lobby of PHP P and Q while three (3) sets of manual call point and fire alarm can be found only on the 5th 10th and 15th floors of each block of PHP P and Q. At PHP R, there is no smoke detector or a complete set of manual call points and fire alarms. Figure 9 show the

vandalized smoke detectors and manual call points.

Figure 9: Vandalized manual call points and fire alarm
