A Fractured Maxillary Canine Restored with a Full Ceramic Crown and Class III Malocclusion

Raja Azman Raja Awang¹, Zohiruddin Adnan¹, Noor Huda Ismail¹

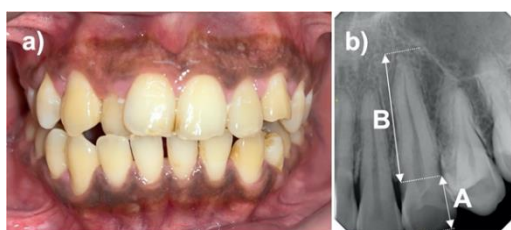
shift and diastema of the lower arch, anterior cross bite of tooth 12, and an open bite between teeth 14 and 44, as shown in Figure 1 a). There was no patient's photograph to refer to confirm the original occlusion for canine relationship on the left side. In addition, there was a lack of lateral guidance because of the fractured crown tooth 23. During the right excursion, the second maxillary and mandibular molar teeth showed contact on the non-working side. The periapical radiograph presented horizontal coronal radiolucency approximating pulp chamber, indicating uncomplicated crown fracture, with normal lamina dura, periodontal ligament space and absence of periapical lesion as shown in Figure 1 b).

Figure 1 Patient in occlusion: a) labial view of tooth 23; and b) periapical radiograph tooth 23 and the landmarks A – crown height and B – root length used for assessment of the crown-root ratio

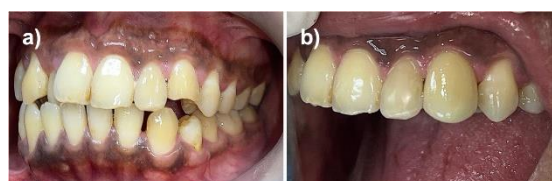
A temporary crown was done using Protemp™ Plus and cemented using eugenol free temporary cement (Freegenol, GC, German). Fabrication of full ceramic crown (IPS e.max, Liechtenstein) done and issued after two weeks. The tooth 23 was isolated completely with cotton wool rolls, aspiration, and a saliva ejector to control moisture before and during cementation. The tooth was acid etched and bond for 20 seconds using a universal adhesive (Scotchbond, 3M ESPE, USA). The crown was cemented with Rely-X U200 (3M ESPE, USA). The patient was reviewed after one week, as shown in Figure 4 b) compared to pre-operative treatment in Figure 4 a). Upon examination, the gum surrounding tooth 23 is healthy. According to the patient, the biting and chewing are just fine. The patient was satisfied with the quality and aesthetic of the tooth. The after-six-month appointment was also given to the patient. However, the patient did not attend the visit and was informed that the crown is still in good condition.

Figure 4 a) Pre-operative photograph; and b) A week E-max crown post-cementation of tooth 23
